April 8, 2018- Twins of a Feather

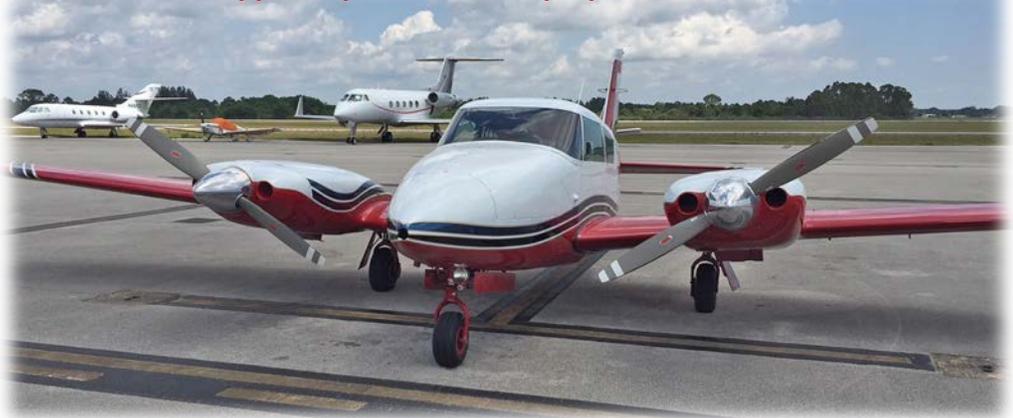
entered into the restaurant. "Interesting that you would mention that." he replied. "I was just telling my passengers that someone was apt to bring it up when they saw my propeller blades. In fact, no that is not the case. I have a problem with the prop governor adjustment which is producing a balance problem that has them out of sync. Something that I need to address but as a result this is the way that they position themselves when parked". We talked a bit more about what turned out to be both our favorite airplanes. This was his 3rd twin Comanche and while the oldest, had the most updated retrofits. He turned out to be a current commercial airline Captain and on his day off, like me, was out for a lunch trip on what was a very enjoyable flying day.

Notice the opposed position of the prop blades- Just like mine

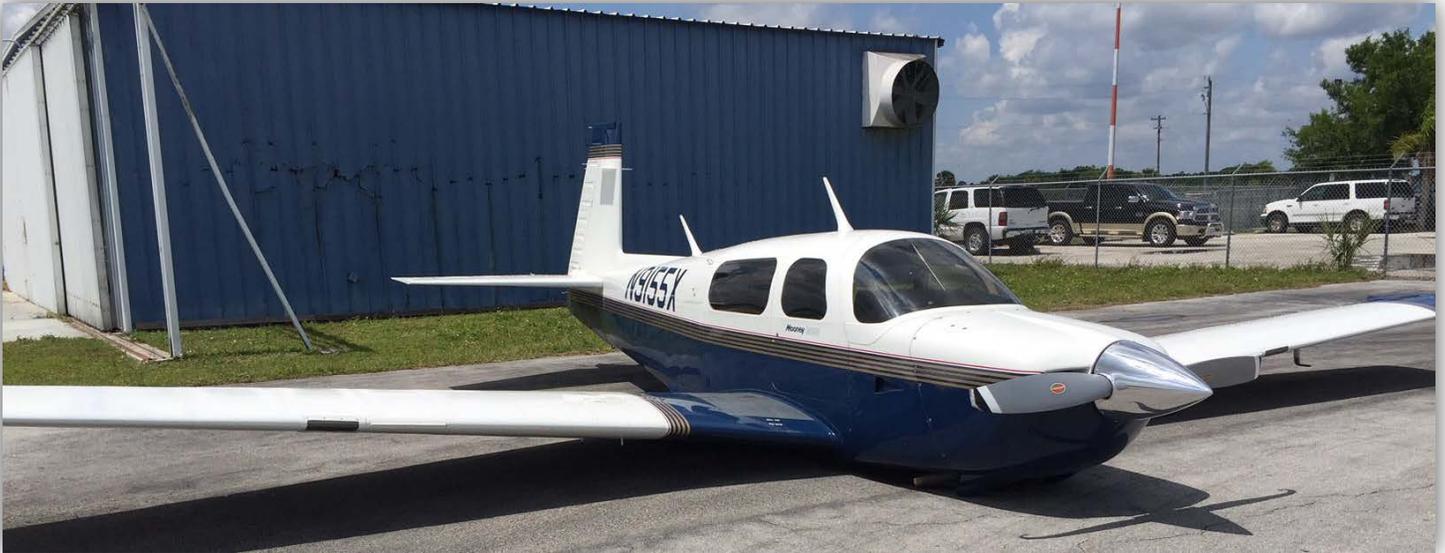
However, it became apparent, after I finished my lunch and began to head back to my airplane, that it might not have been all that enjoyable recent flying day for another private pilot. I noticed what appeared to be an unusual position for a Mooney airplane parked just a short walk over from the restaurant. I wandered over and found what might be called a "low rider". However it did not attain this very low profile from a tricked out modification to its suspension. It had all of the classic signs of a "gear up" landing; something that is not all that uncommon to retractable wheeled airplanes. It is usually caused by inattention by the pilot along with the

absence of using a landing check list while on final approach. This is something that almost happened to me with my single engine Piper Comanche on a flight up to Buffalo, NY back in the '70s. I failed to call out my standard **GUMP** check list while on final, ie: **GAS** (on proper tanks and electric fuel pump in the on position), **UNDERCARGAGE** (gear in down position and locked with all 3 green lights showing "safe", **MIXTURE** (in the full rich position, to keep the cylinders from overheating, just in case a "go around" becomes necessary, and **PROPELLER** (pushing the prop controls into the high RMP setting to aid in climb performance in case full power is required for that "go around".)

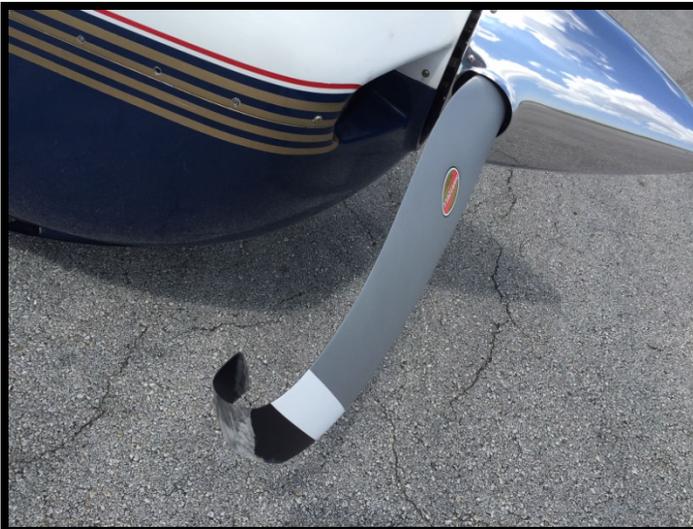
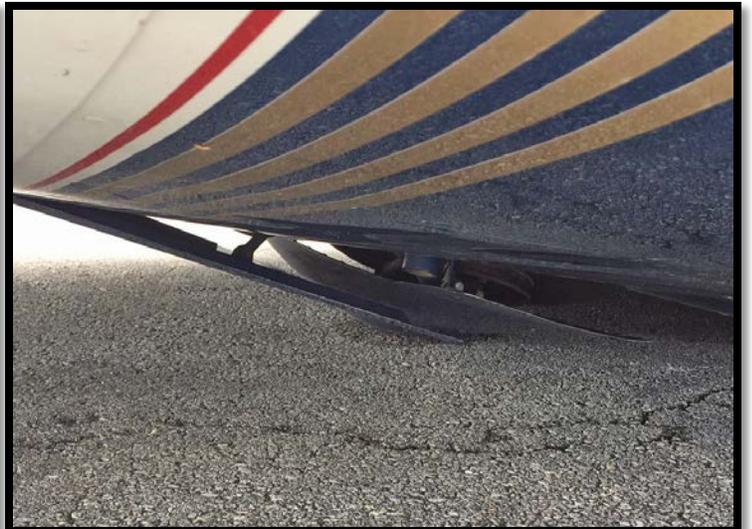
Here we have photo evidence of that gear-up landing. On the left we see the curled back prop tips from their contacting the runway asphalt and on the right is a view of the planes underbelly showing that the gear doors

are still up and the wheels fully retracted. Although it appears that the plane did not sustain much undercarriage or wing damage, there will still be a LOT of money spent as the engine will have to be entirely disassembled and rebuilt. The prop will need to be replaced along with its adjusting and governing components. And, of course, all torn-up sheet metal will have to be replaced and repainted. The wings will also need to be checked for structural damage and possibly re-rigged. We are looking at a \$100K, *minimum*, repair here.
